BP Pipelines (North America) Inc. 28100 Torch Parkway Warrenville, Illinois 60555

RE: CPF 2-2010-1003W

Destin Pipeline Company, LLC Operator ID #31088

# Item #3) 192.709 Recordkeeping and 192.739 Inspection & testing of pressurelimiting and regulating stations

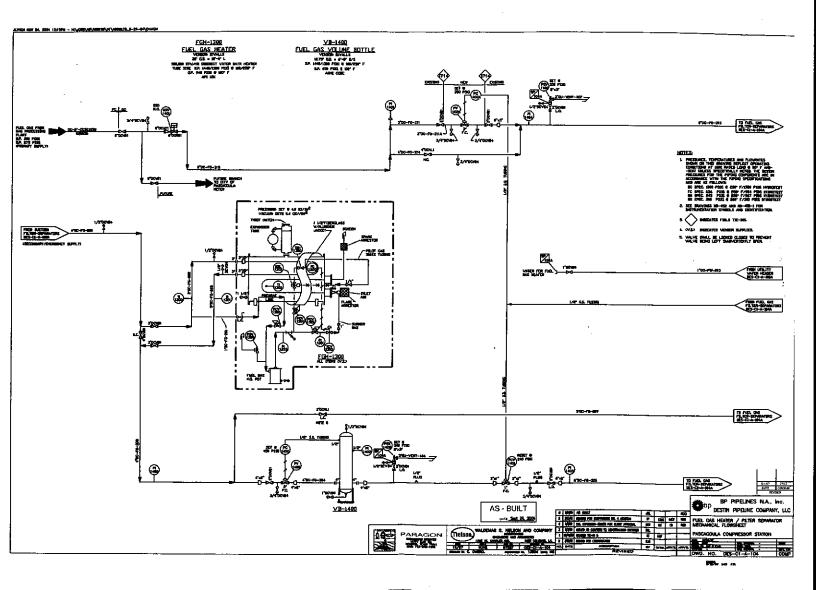
In consideration of PHMSA's 192.3 definitions for "Pipeline" and "Pipeline facility" Destin does not consider a "turbine fuel gas heater/filter separator" a jurisdictional device and therefore does not consider the pressure regulating control valve (PV-1400) servicing the fuel gas heater/filter separator a jurisdictional device. This device is located on the backup fuel gas line to the turbine that drives the compressor, downstream of the fuel gas heater. This device does not provide over-pressure protection for the transmission pipeline but rather steps down the pressure in the fuel gas line providing a steady feed into a volume/pulsation vessel prior to introduction into the gas turbine driver. See the enclosed drawing Pascagoula Compressor Station Fuel Gas Heater/Filter Separator Mechanical Flow Sheet Drawing Number DES-C1-A-104.

BP Pipelines submits the attached additional information in response to the issues raised in the warning letter. Also included is the drawing Pascagoula Compressor Station Fuel Gas Heater/Filter Separator Mechanical Flow Sheet Drawing Number DES-C1-A-104 which relates to Item No.3. It is our belief that these responses address PHMSA's concerns as described in CPF 2-2010-1003W.
